**LIMITED PROPERTY CONDITION EVALUATION REPORT  
ST. MARY CHURCH  
510 PROSPECT AVENUE  
ALMA, MICHIGAN**

**DIOCESE OF SAGINAW  
5800 WEISS STREET  
SAGINAW, MICHIGAN 48603  
ATTN: MS. STEPHANIE FLYNN**

May 24, 2019  
Project No. 14250S-1-196

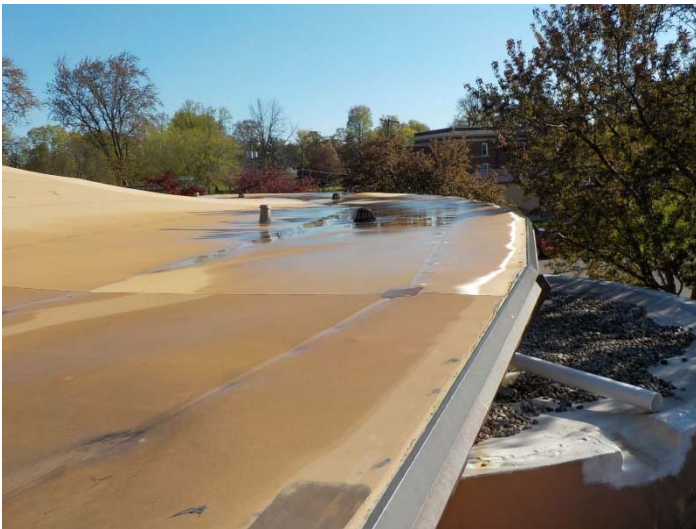
In general, the roofing systems associated with the buildings were observed to be in poor condition. The roof surfaces of the spires located above the Church are asphalt shingles, which appear to be in poor condition. The remaining surface of both the Rectory and Church are of mechanically fastened or ballasted membrane design and installation. Ponding and poor drainage was observed on the flat membrane areas of the roof. Extensive areas of leaks were observed inside the Church, with lesser evidence in the Rectory. Roof drainage at the Church is facilitated by downspouts that extend from the roof through the overhang and past the soffits. Below the soffits, water moving through the downspouts free falls from between 5 and 10 feet to the ground surface. Observable areas of the building soffits indicates this part of the building is in very poor condition with widespread water damaged wood and exposed/open areas. Reportedly, these exposed/open areas allowed the building to be infested by bats but the penetrations could allow for other animals (i.e., birds, squirrels, racoons, etc.) to enter and live in attic areas.

**View of membrane roof with ponding.**

Due to the condition, roof system, downspout and extensive soffit restoration is recommended.

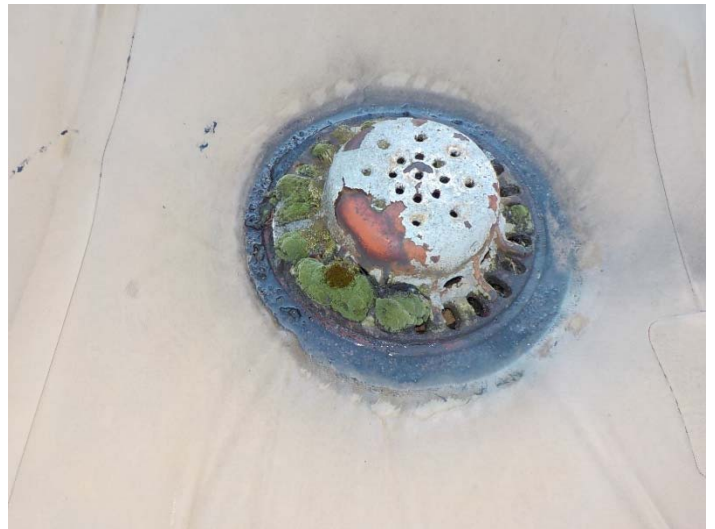
**View of vegetation in roof drain.**

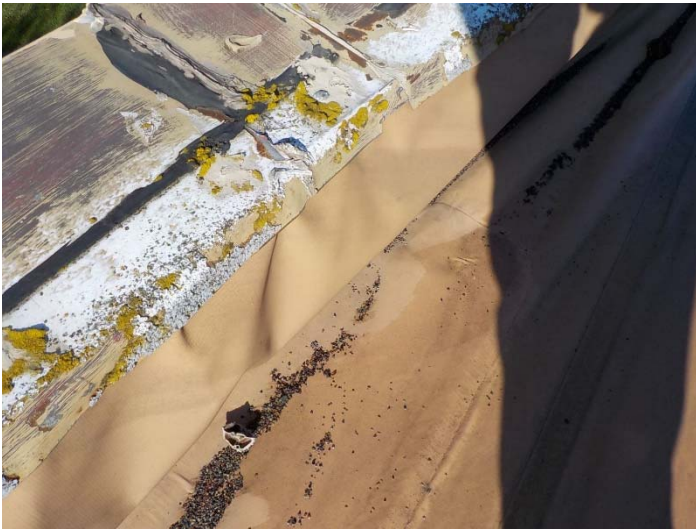
**View of damaged roof flashing.**

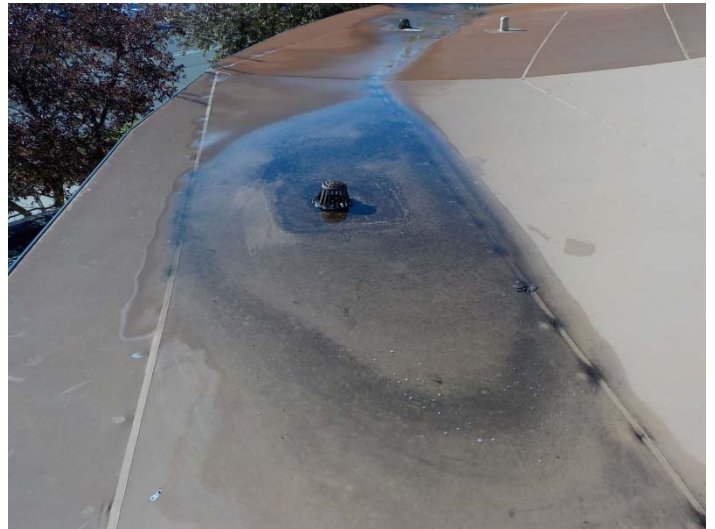
**View of ponding at roof drain.**

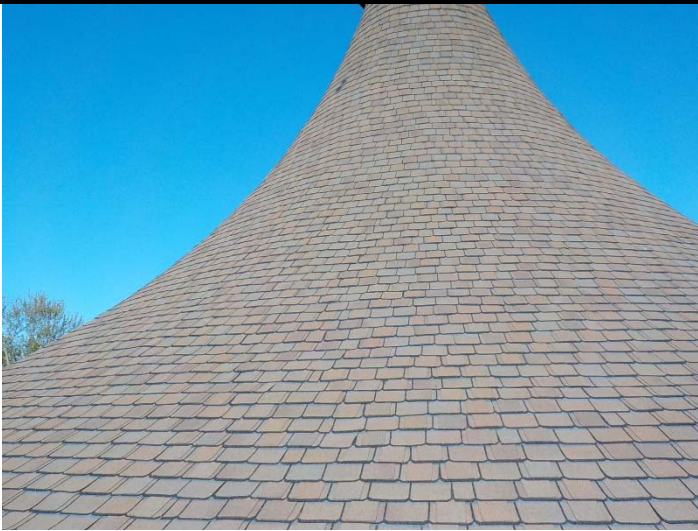
View of steeple roof with missing shingle.

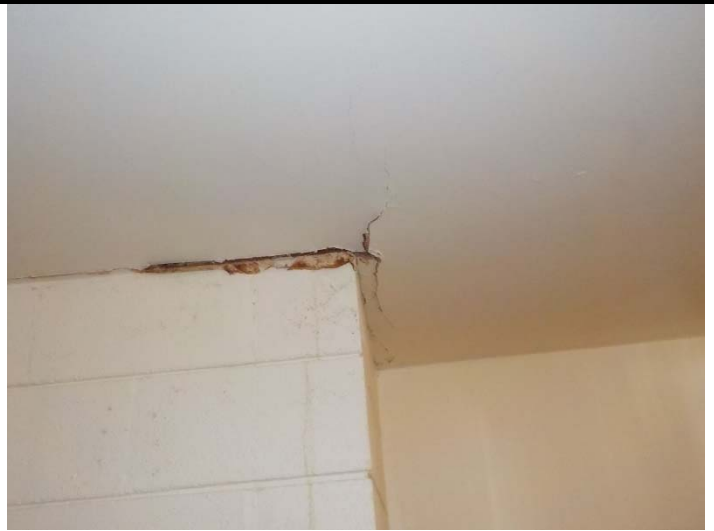
View of roof leak in Rectory.

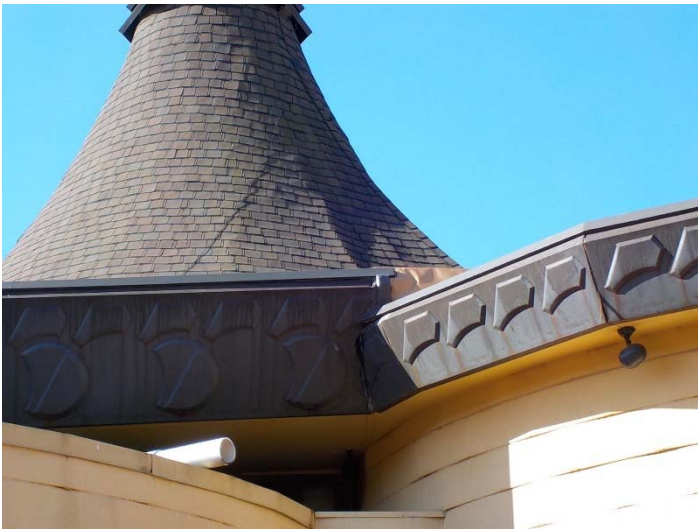
View of ageing (degraded) Church steeple.

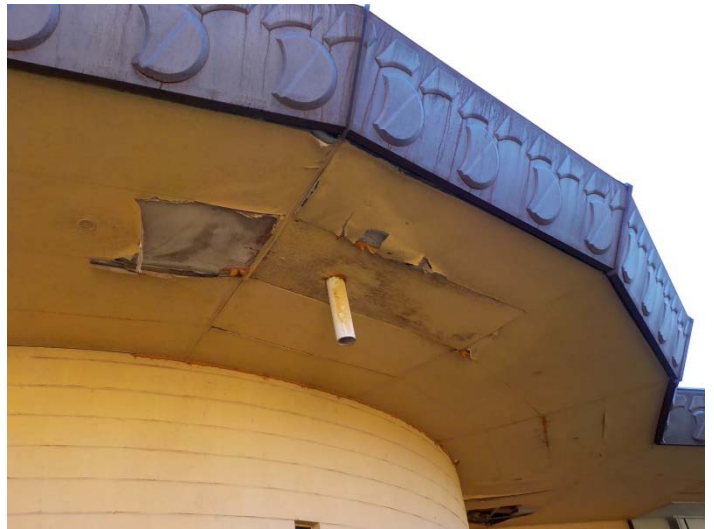
View of damaged soffit and inadequate roof drain.

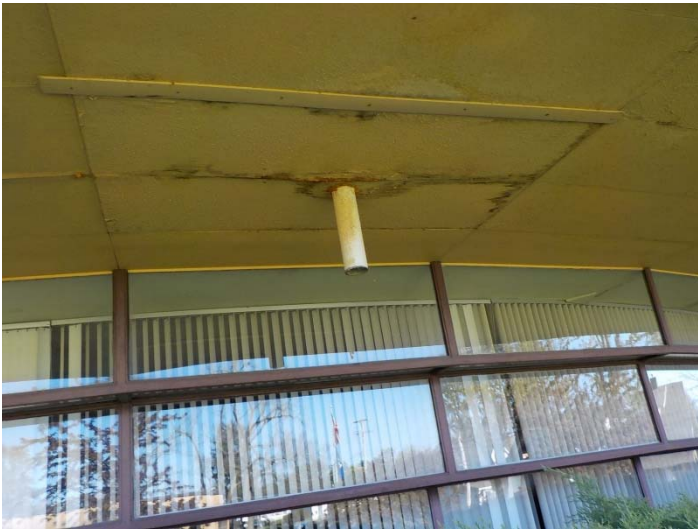
View of damaged soffit and inadequate roof drain.

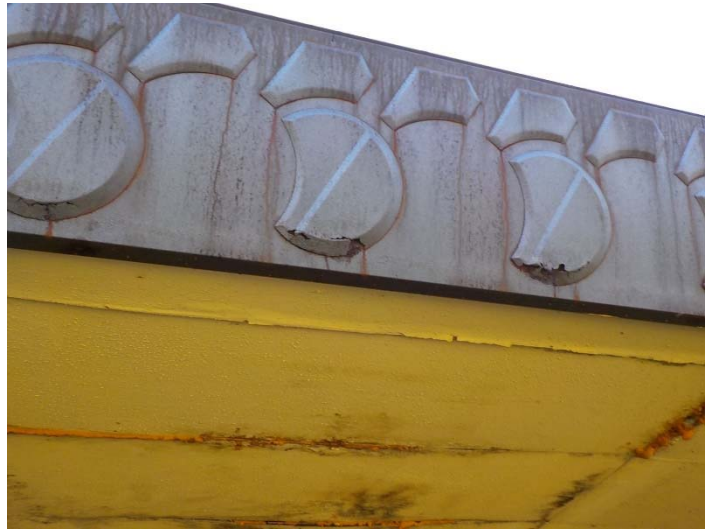
View of oxidized (rusting) fascia and damaged soffit at Church.

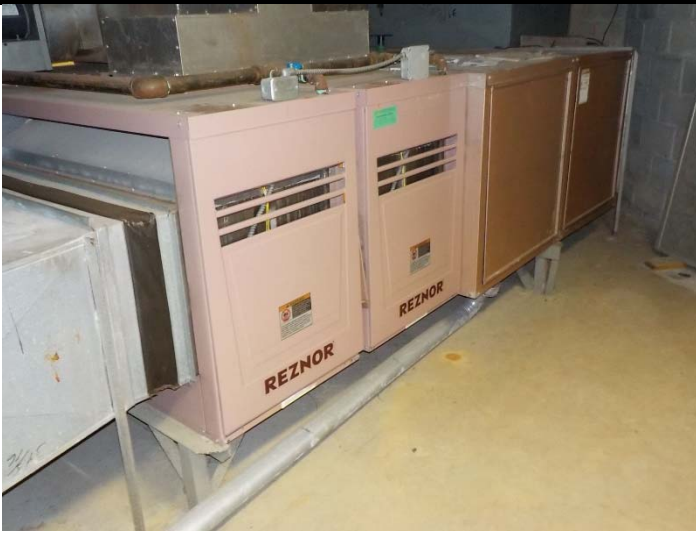
View of boilers for Church.

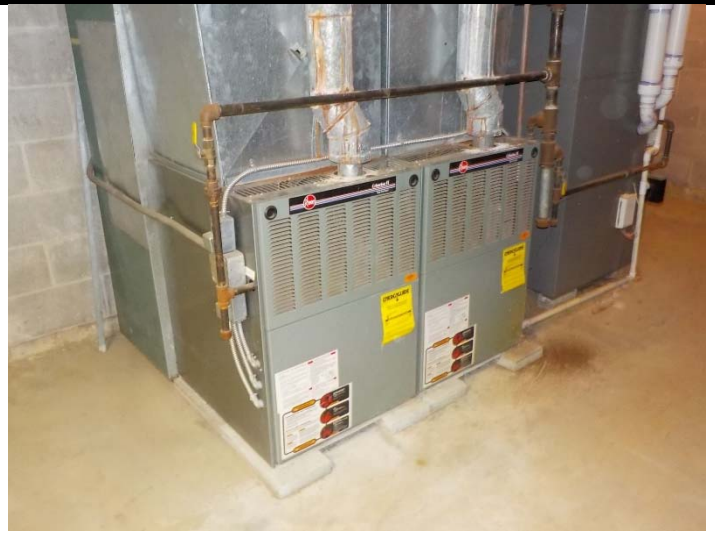
The Church is heated by two (2) Reznor forced hot air units and the Rectory is heated by two (2) Rheem forced hot air units. The two (2) Reznor units were installed in 2006, are in good condition and within the effective useful life (EUL). Although in good condition, regular preventative maintenance may extend these units beyond the EUL. The two (2) Rheem units were installed in 1996 and have reached the end of the respective EUL. While the Rheem units servicing the Rectory are currently in working order, due to the age, replacement should be considered.

View of forced hot air furnaces for Rectory.

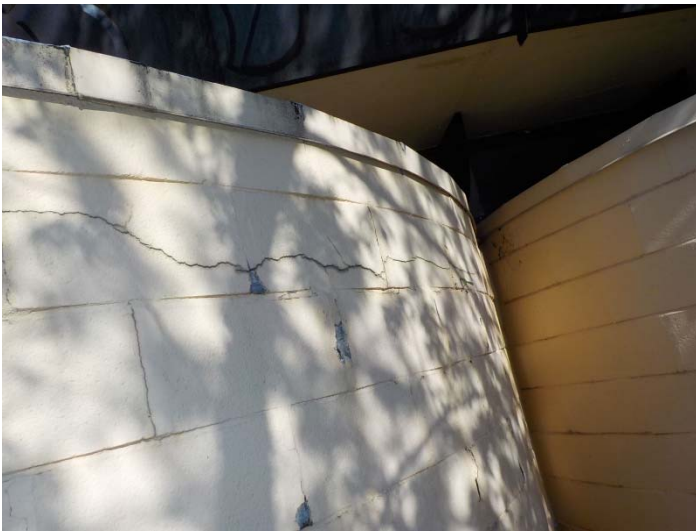
The building exterior is of painted concrete block construction with a metal fascia that extends around the perimeter of the structure. Overall, the exterior surfaces of the buildings are in poor condition. Concrete blocks exhibit some longitudinal cracking, paint is chipped and peeling, and it was reported by parish personnel that a brick veneer was planned for the original construction but was never installed. Removal of the possible lead-based paint, re-painting the entire masonry exterior, refurbishing and possible replacement of entire perimeter fascia are recommended. For improved exterior appearance, installation of a brick façade could be considered as a capital improvement.

View of damaged block wall at the Church with stress crack.

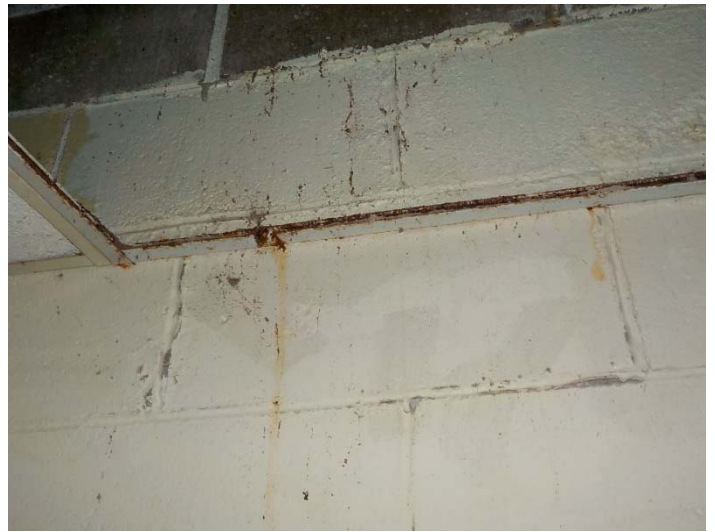
View of water infiltration area in Rectory basement.

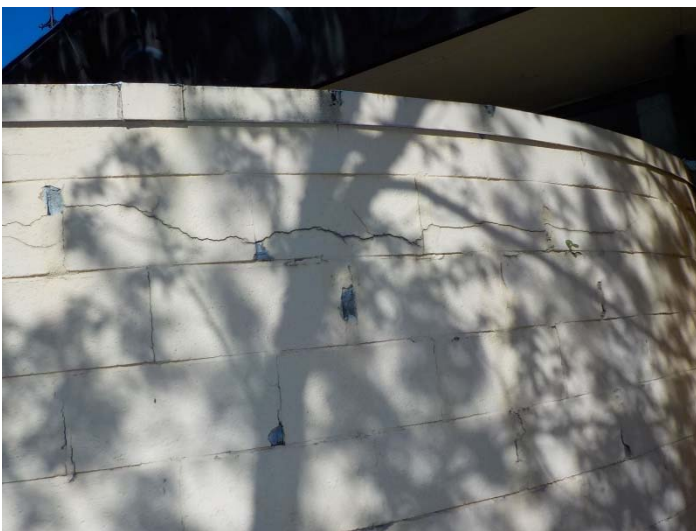
View of damaged block wall at the Church with stress crack.

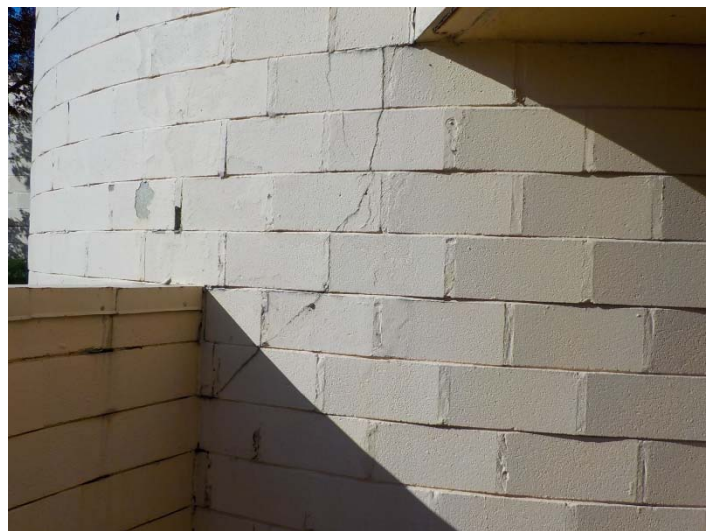
View of damaged block Church wall with stress crack.

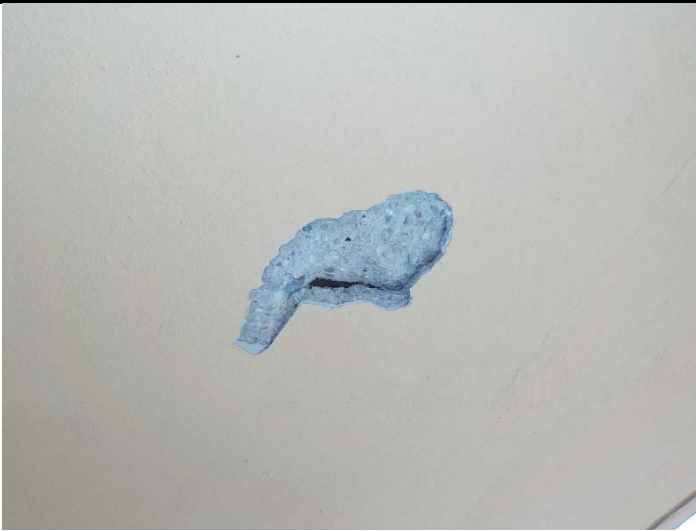
There is also a concrete vestibule over the main entrance to the Church that is in poor condition. During the site reconnaissance, exposed, rusted reinforcement rod was observed, and parts of the vestibule overhang are delaminating from the substrate and falling. This is both a visual concern and potential safety hazard. The vestibule will require extensive repair or replacement due to safety concerns.

View of delaminating concrete at Church entrance.

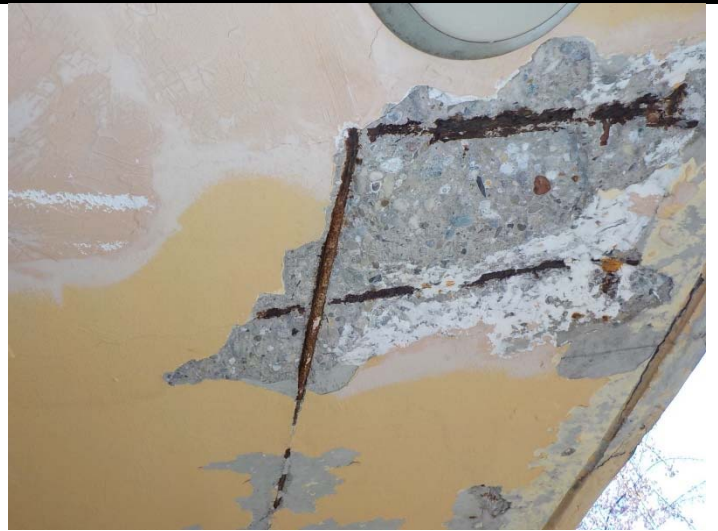
View of delaminating concrete at Church entrance.

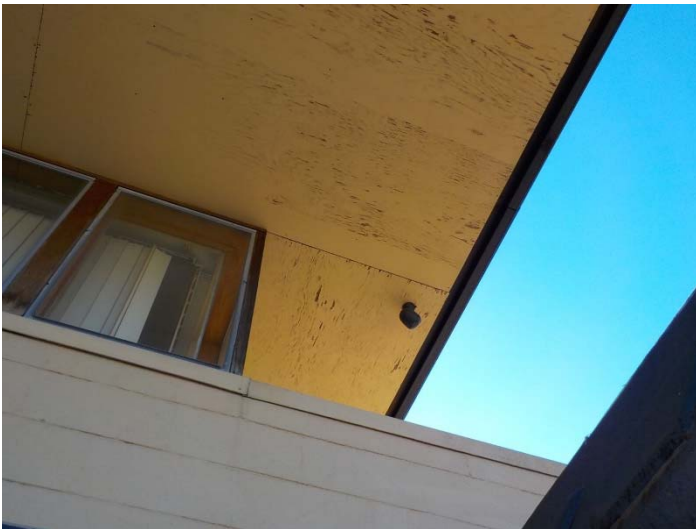
View of soffits requiring paint at Rectory.

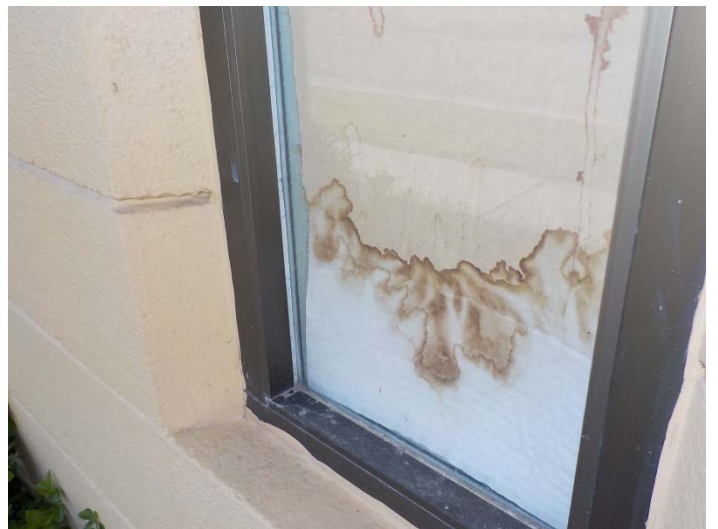
View of typical single pane window.

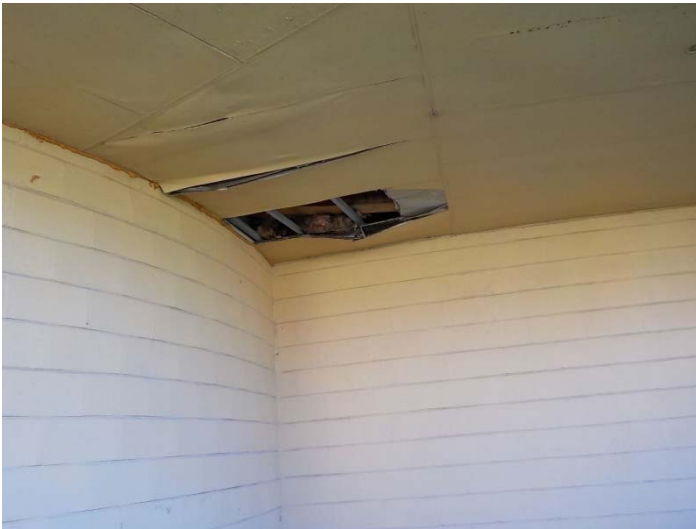
View of damaged wood soffit and insulation.

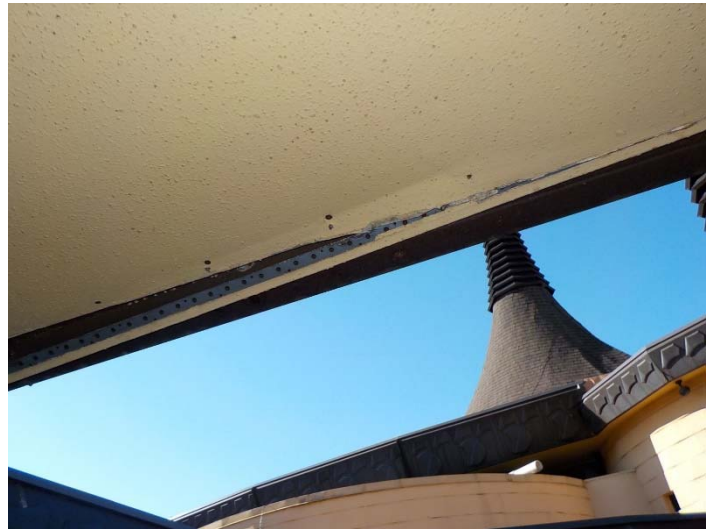
View of damaged soffit at Rectory.

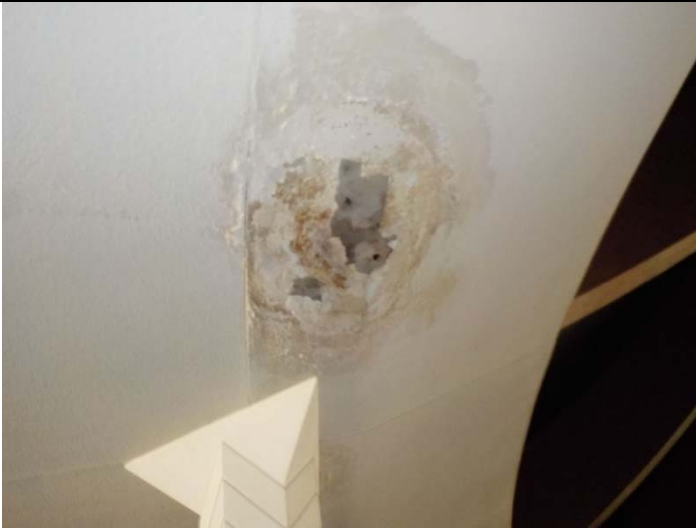
The interior plaster ceiling of the Church is in poor condition and will require repair and or replacement, largely due to water damage from roof leaks. Observation of the plaster and substrate suggests there is widespread damage to the ceiling structure throughout the Church. Water intrusion has also likely damaged much of the building insulation between the ceiling and roof deck. Along with ceiling support repairs, replacement of building insulation will probably be required. AKT Peerless did collect a single sample of the ceiling plaster to determine if any asbestos was present. That single sample did not detect any asbestos. Please note, this is not and was not intended to be an asbestos survey, simply a preliminary determination of potential asbestos concerns. Any renovation or demolition of the building should include a detailed and complete asbestos survey and inspection. The Church area, including the pews, and the Rectory are covered by a carpet that appears to be original to the building construction. Some of the carpet is water damaged from roof leaks, years of use (most carpet has a 7 to 10-year EUL). Replacement of the carpet due to age, water damage (mold), and animal droppings from prior bat infestation is strongly recommended.

View of damaged plaster in the Church.

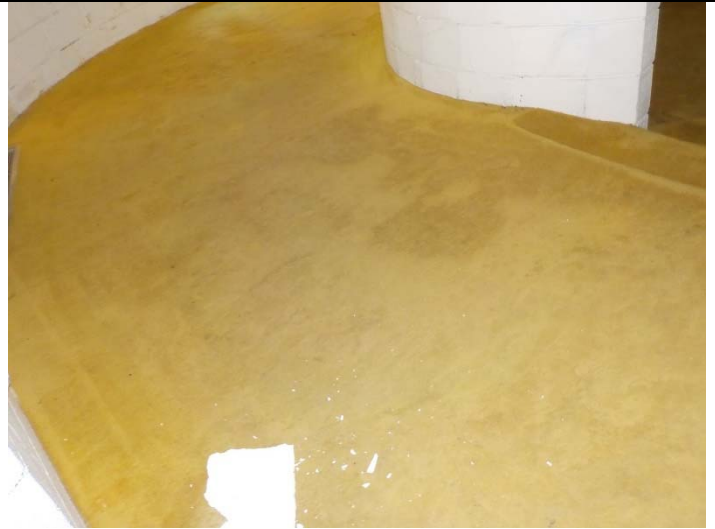
View dated carpet with water damage in Church.

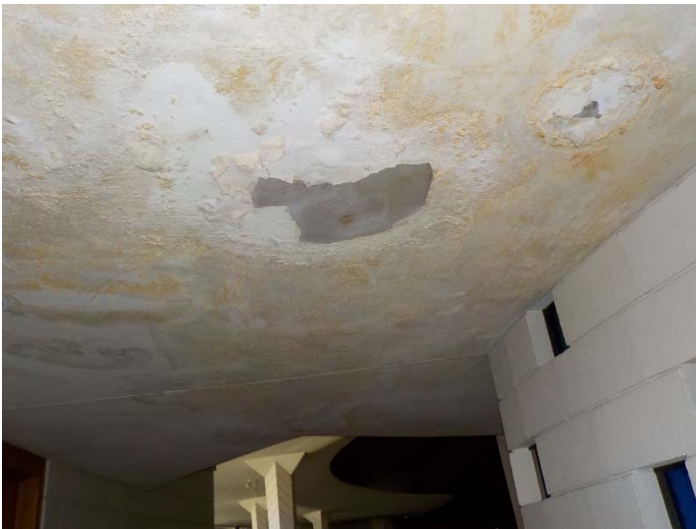
View of damaged plaster in Church.

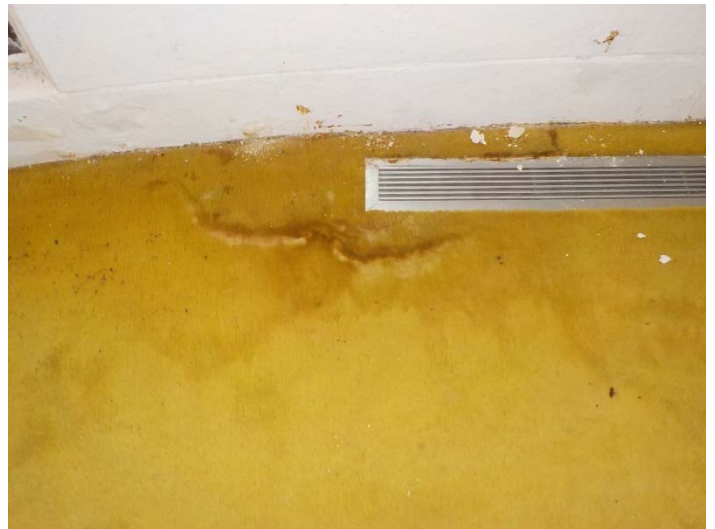
View dated carpet with water damage in the Church.

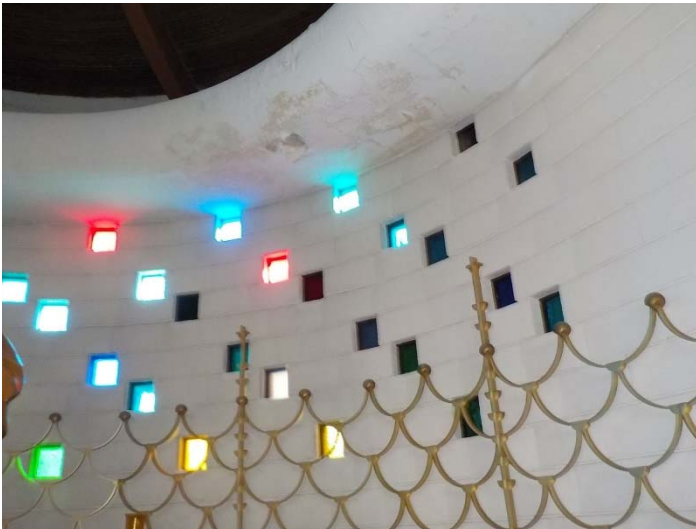
View of water damaged ceiling plaster in the Church.

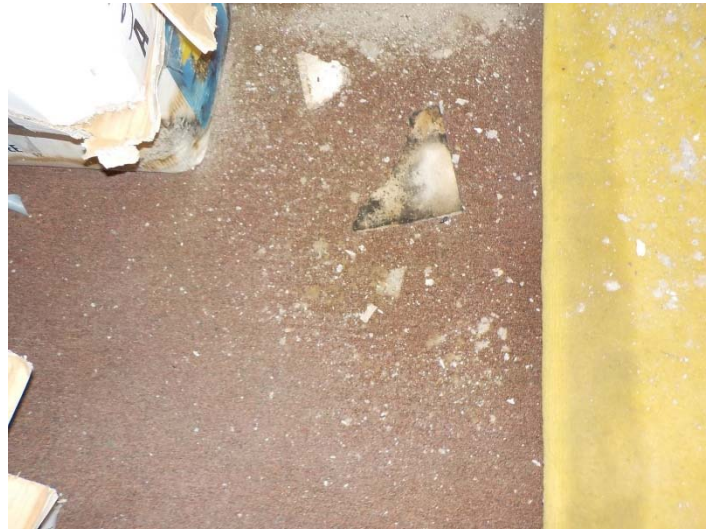
View of failing plaster in Church.

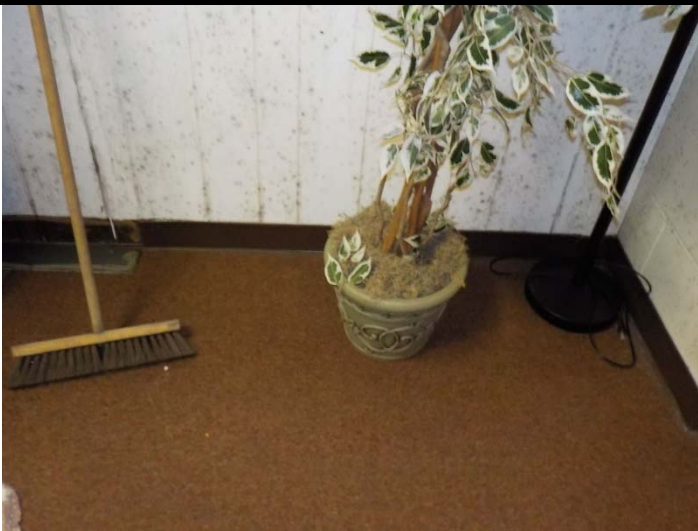
Mold was observed in the Rectory basement and garage and is likely present in areas above the ceiling in the Church. Before either structure is regularly occupied, a complete mold survey and abatement are recommended.

View of mold in the Rectory basement.

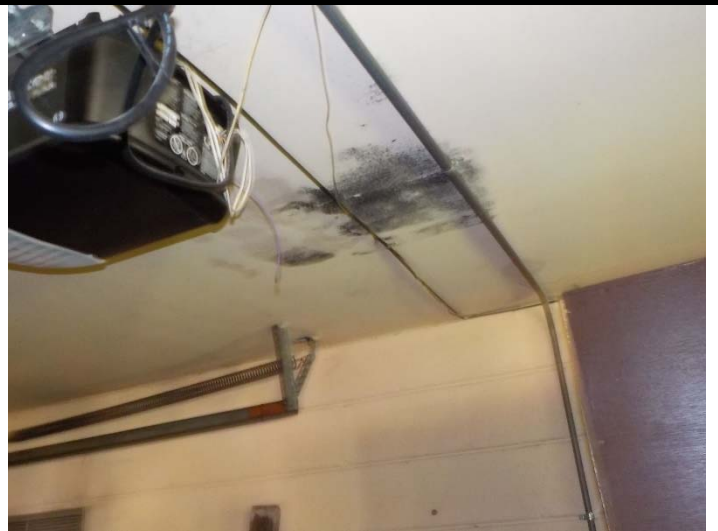
View of mold in the Rectory garage.

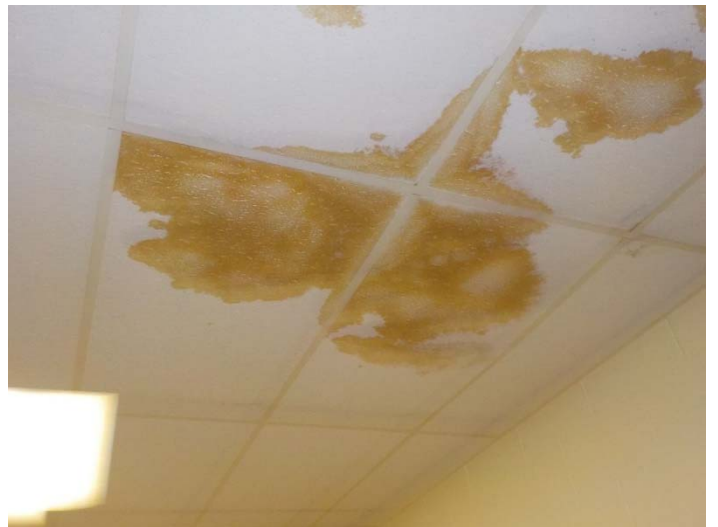
View of water damaged ceiling tile in Rectory basement.

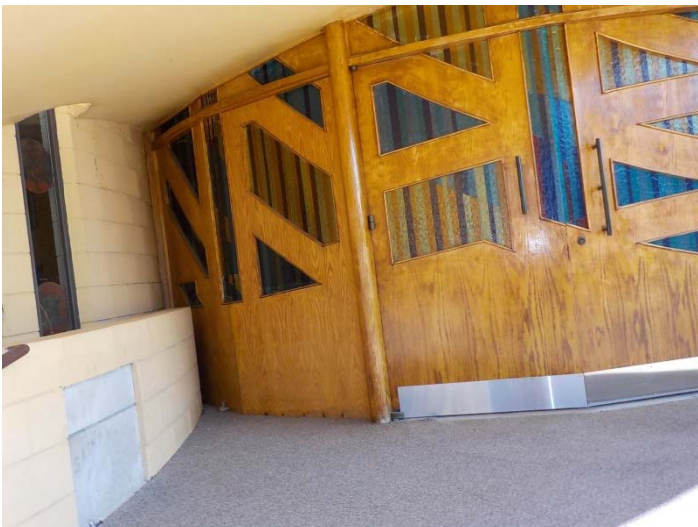
The exterior doors are of wood construction and appear to be in fair condition but all require refinishing by paint or stain. Oil staining from leaking door actuators was observed, which may require some localized repair or replacement.

View of Church entrance doors, requires refinishing.

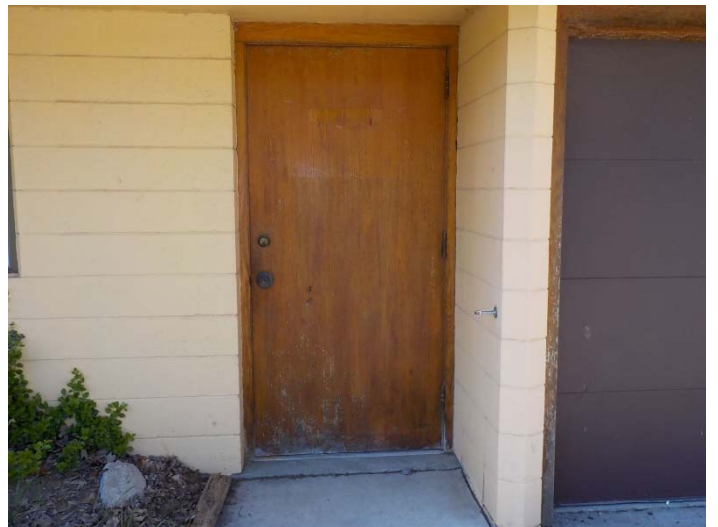
View of entrance doors, requires refinishing.
